# Washington Department of Fish and Wildlife

Road Name:	<input type="text" value="I-5; SB"/>
Mile Post:	<input type="text" value="211.70"/>
County:	<input type="text" value="Snohomish"/>
WDFW Region:	<input type="text" value="4"/>

## Level A Culvert Assessment Report

Site ID: <b>990623</b>	Stream: <b>Secret Cr</b>	WRIA: <b>05.0065</b>
Latitude: <b>48.227199</b>	Tributary To: <b>Pilchuck Cr</b>	Fish Use Potential: <b>Yes</b>
Longitude: <b>-122.228295</b>

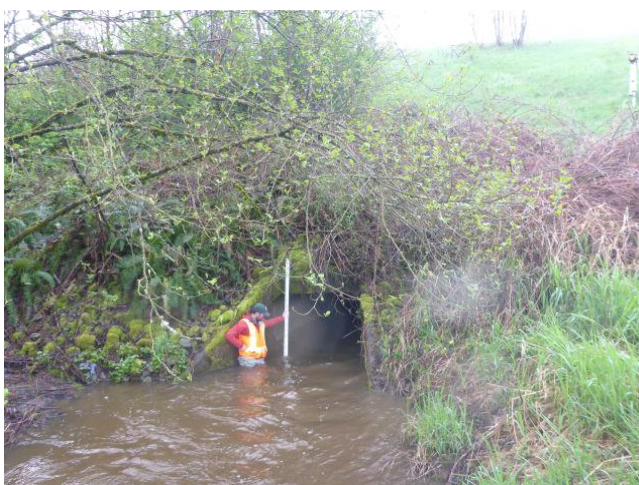
<b>Assessment Results</b>		Tidal Influence: <input type="text"/>	Tidegate Present: <input type="text" value="No"/>
Barrier: <input type="text" value="Yes"/>	Passability (%): <input type="text" value="67"/>	Method: <input type="text" value="Level B"/>	
Reason: <input type="text" value="Velocity"/>	Fishway Present: <input type="text" value="No"/>	Recheck: <input type="text"/>

<b>Comments</b>
This is the southbound lane culvert. Culverted under both the south bound lanes of I-5 and Old Hwy 99. Thin layer of bed material at outlet. Wing walls at DS end. No bed material at US end. [Lvl B, Fredley, FishXing, 5/1/18].
